ROTHESAY PAVILION - PROJECT UPDATES

PROGRESS UPDATE – MAY 2024

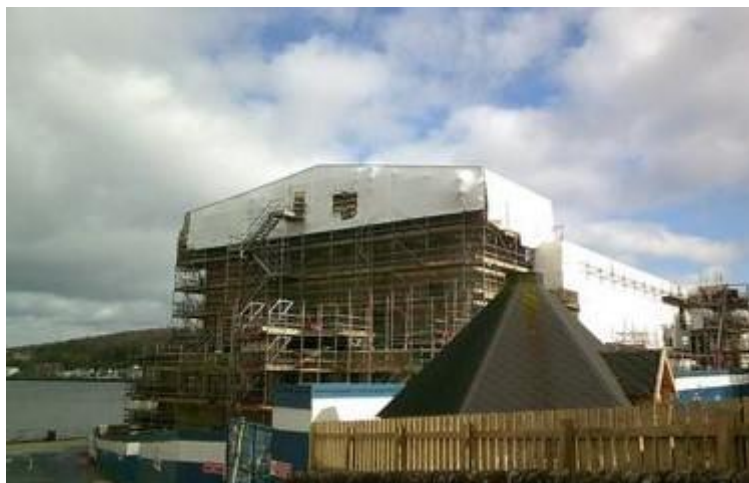
Figure 2 ROOF 3 (FLYTOWER ROOF) TEMPORARY ROOF COVERING VIEWED FROM MACKINLAY STREET.

- Roof 3 (Flytower overlooking McKinley Street) Temporary roof trusses and polythene 'tent' have been installed.
 - Existing stone copings to all 4 elevations have been removed.

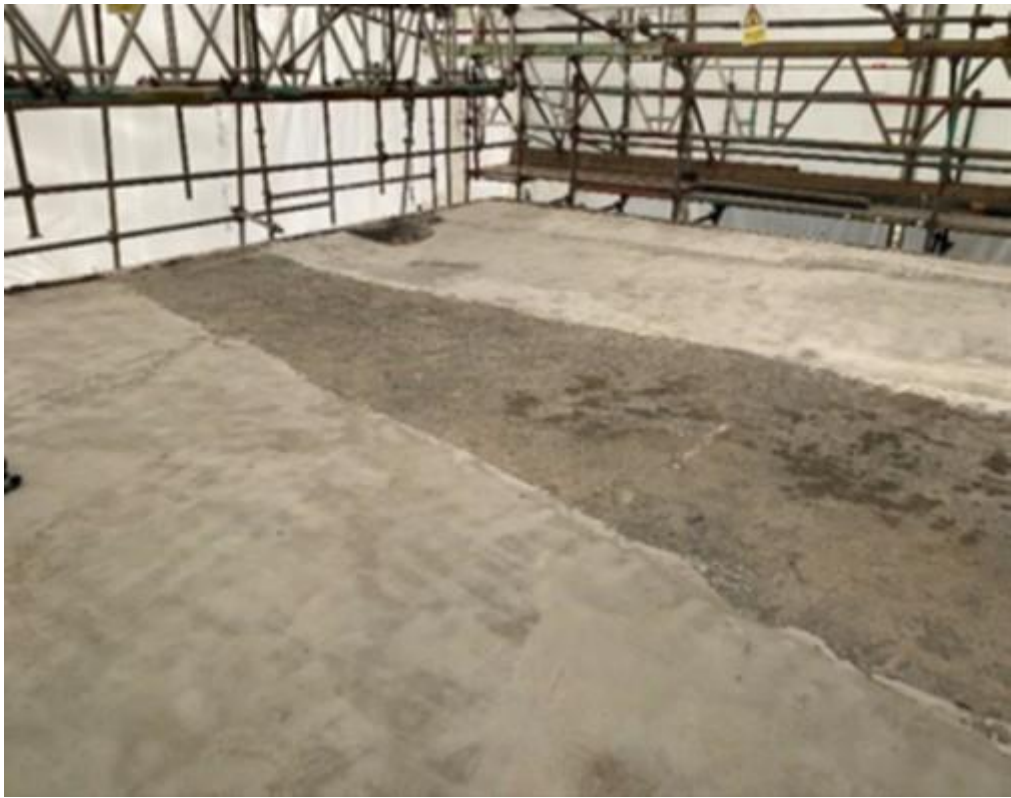
Figure 3 ROOF 3 FLYTOWER: LEVELLING SCREED POURED IN REPAIR AREAS PRIOR TO INSTALLATION OF VAPOUR CONTROL LAYER (VCL).

- Existing roof covering has been stripped/removed.
 - Surveys of the existing concrete roof substrate have been undertaken and noted repair works nearing completion.

- Roof 3 (Flytower overlooking McKinley Street)
 - Complete concrete roof substrate repair works.
 - Install new rainwater outlets.
 - Progress with installation of new insulated tapered insulation roof build up.

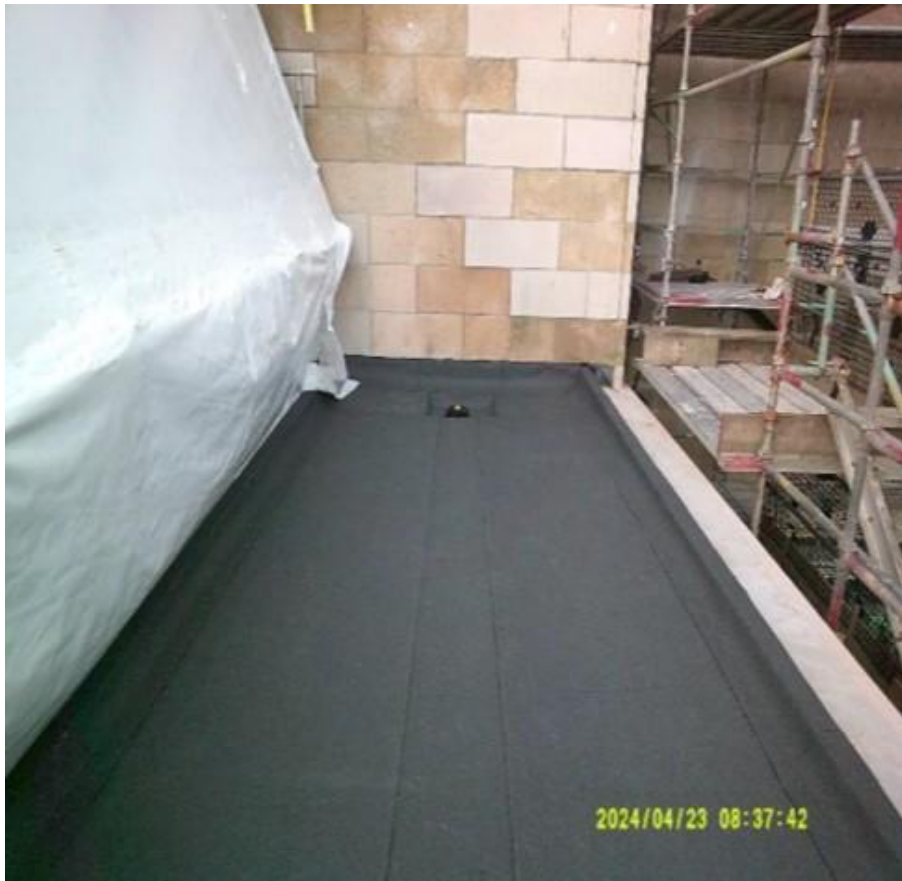
Figure 5 ROOF AREA 3A: THE NEW ROOF MEMBRANE PARTIALLY LAID. THE EDGE DETAIL IS WORK IN PROGRESS TO IMPROVE THE DISCHARGE OF RAINWATER.

- Progress with reinstatement of stone copings.
- Roofs 3a, 3b: (overlooking Argyle St.) progress with works.
- Roofs 4a & 4b (overlooking Argyle St.): Remove existing roof covering to existing terrace roofs.

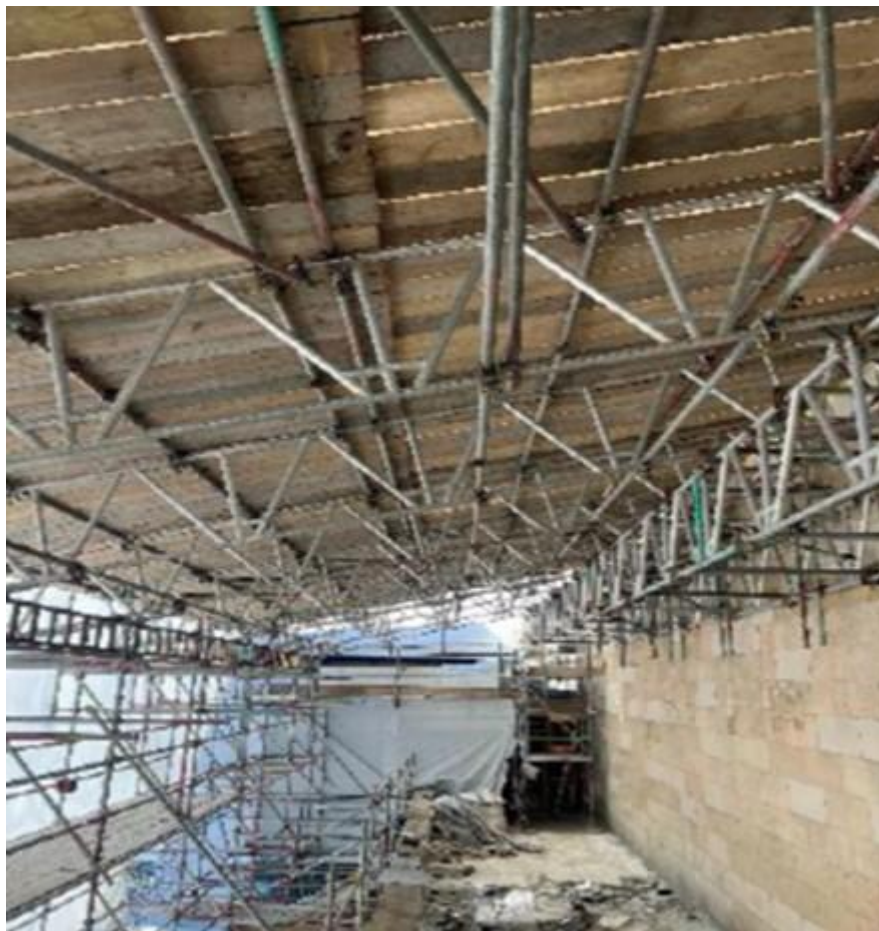
Figure 6 ROOF 4A (OVERLOOKING ARGYLE ST.) TEMPORARY ROOF SCAFFOLD INSITU. EXISTING MEMBRANE ON ROOF 4A BEING REMOVED.

- Roofs 2e, 3c, 3d, 4, and 5b (South Elevation – see roof plan) have been completed.
- Roofs 4a & 4b (Front terraces overlooking Argyle St) installation of access/support scaffold, roof trusses and polythene protective 'tent' erected and insitu.
